GE 27990G3 Cordless Phone Teardown

Full teardown of a cordless phone from 2001.

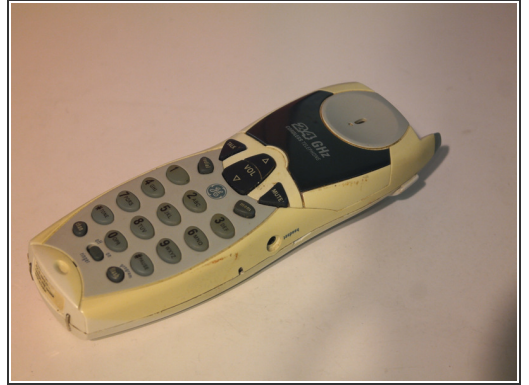
- This is a teardown of a GE 27990G3 cordless phone system from 2001. Sadly, while it still works, its 2.4 GHz wireless transmitter interferes with WiFi.

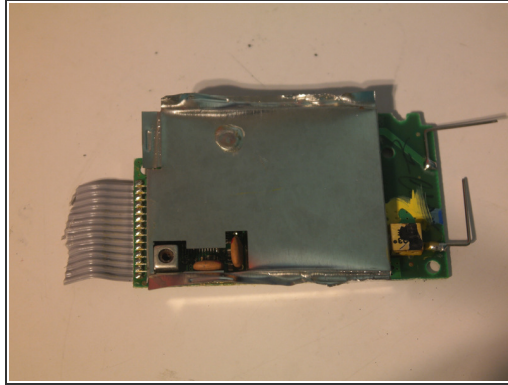
- Whoever designed the wireless module really didn't want anyone to know what was inside. The very thick EMI shield is **soldered, crimped, and epoxied on**.
- The shield took about 20 minutes to remove with diagonal cutters, 2 pairs of pliers, and 3 metal spudgers.
- Needless to say, the shield is irreversibly damaged and the wireless module will probably never work again.

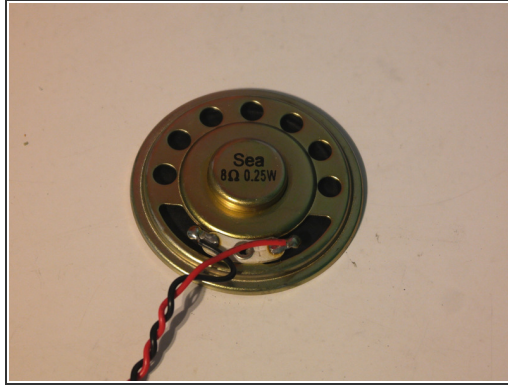
- The major components on the top case board:
 - Dual 7-segment display
 - [LM386](#) audio amplifier
 - Message indicator LED
- This board was manufactured on July 27, 2001.
- The speaker is a standard 2" low profile 8 ohm 0.25 watt speaker.
